Startup Creek
Pipeline MP 64.77
ADF&G Stream No. N/A
Site Visit: 8/16/05

Prepared by: RSM CONSULTANTS, INC.

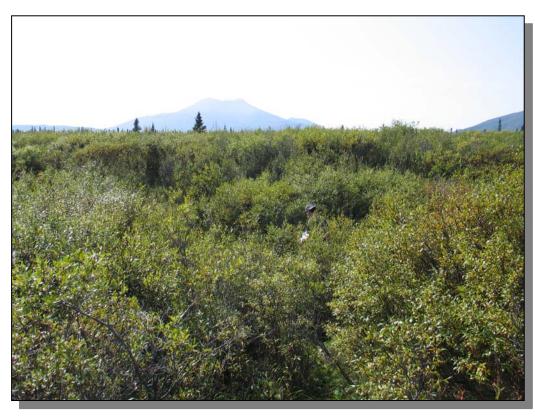
Looking cross-stream toward the west and Gunsight Mountain.

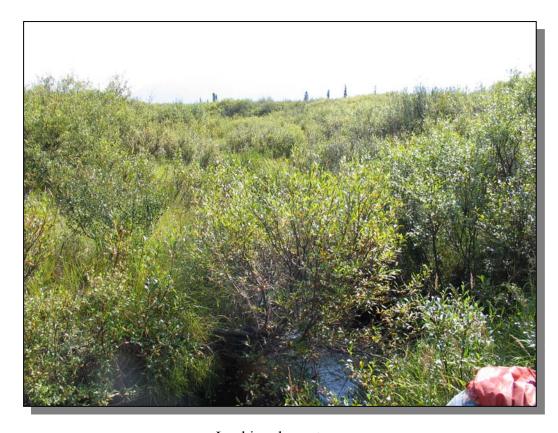
Looking downstream

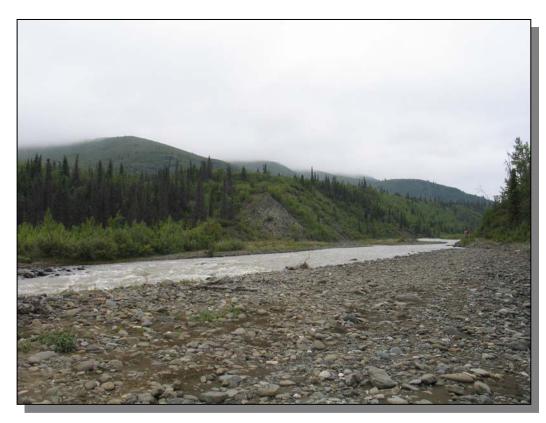
Approximate location of proposed Caribou Creek crossing, looking upstream.

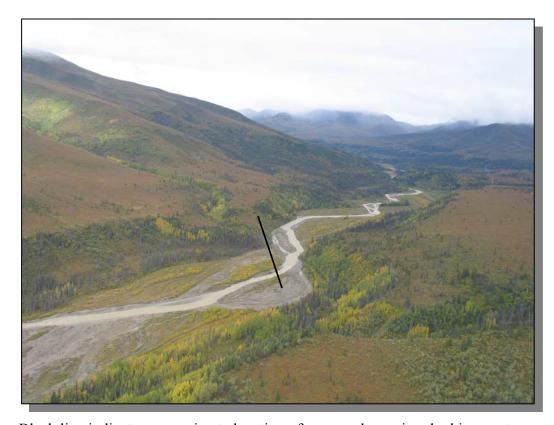
Black line indicates approximate location of proposed crossing, looking upstream.

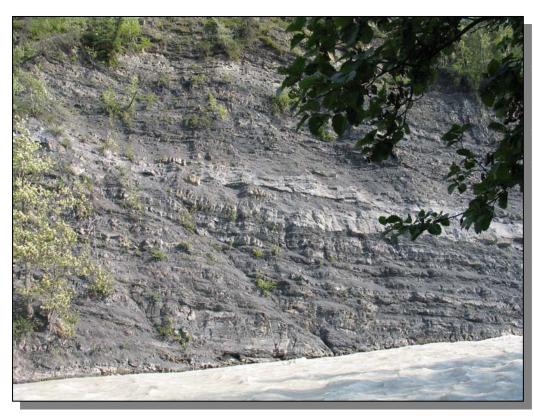
Bedrock Description: Left (east) bank bedrock generally consists of mudstone, siltstone, and conglomeratic sandstone. No bedrock was observed on the right (west) bank of the proposed crossing.

Left (east) bank weathered bedrock slope of Chickaloon River. Looking slightly downstream from right (west) bank.

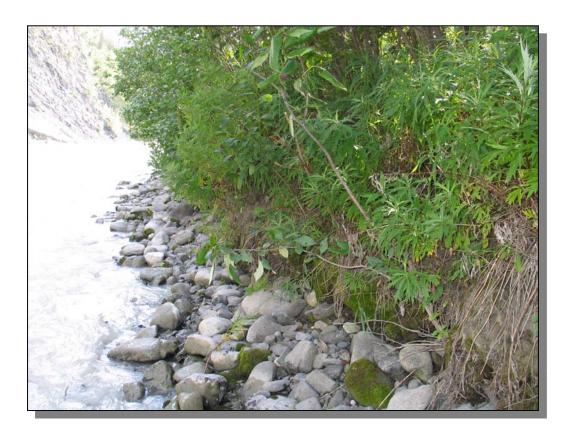
Soils Description: Right (west) bank soils and stream bed soils are interpreted as being floodplain and floodplain terrace deposits consisting of rounded cobbles and boulders, gravel, and sand, both sorted and layered. Soils are considered to be unfrozen, with good drainage. Permafrost is not anticipated at this crossing location.

Right (west) bank floodplain deposits, looking downstream.

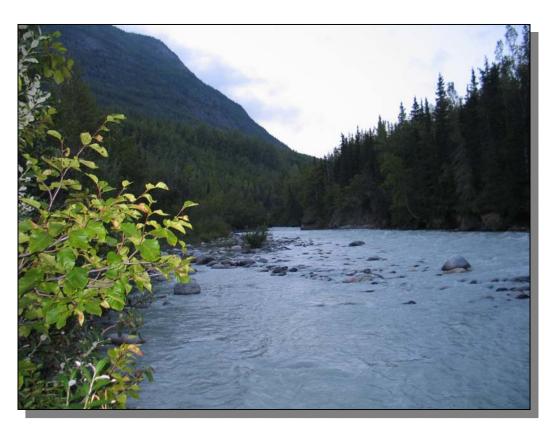
Bedrock Description: Bedrock exposures were observed immediately adjacent to the east and west bank floodplain and floodplain terrace deposits. Depth to bedrock within the stream channel may be fairly shallow.

Right (west) bank floodplain deposits and east bank bedrock outcrops, looking upstream.

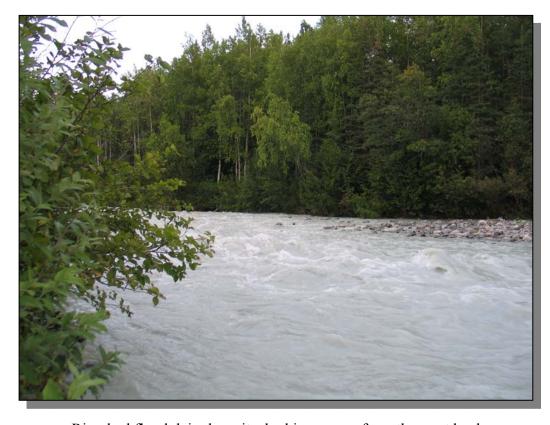
Riverbed floodplain deposits, looking across from the west bank.

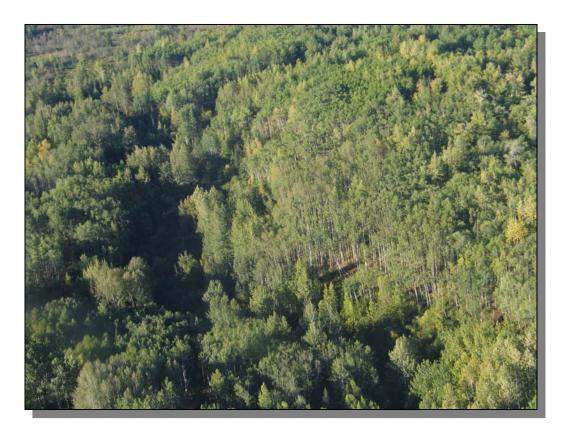
Looking downstream from directly above the approximate location of the proposed crossing.

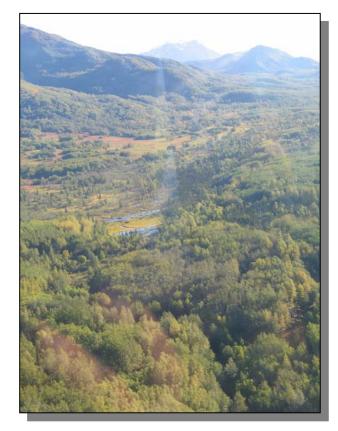
Looking east along pipeline alignment from directly above Little Granite Creek crossing.

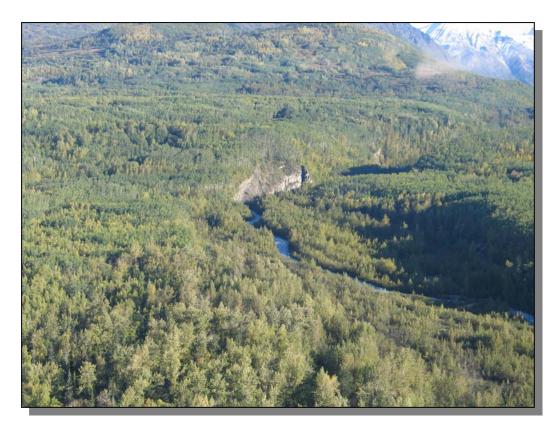
Approximate location of pipeline crossing, looking upstream.

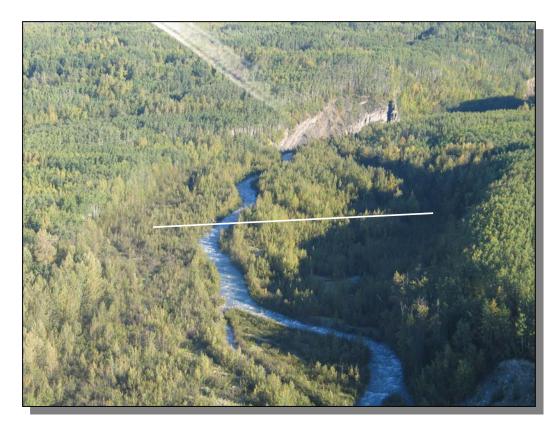
<u>Bedrock Description</u>: Approximately one-quarter mile upstream of the crossing, a bedrock slope exposure is present (see photo). Depth to bedrock is unknown at the actual crossing location and vegetation cover precluded the observation of the remaining stream bed and stream banks during helicopter over-flight.

White line indicates approximate location of pipeline crossing, looking upstream. Note bedrock exposure in upper center of photo.

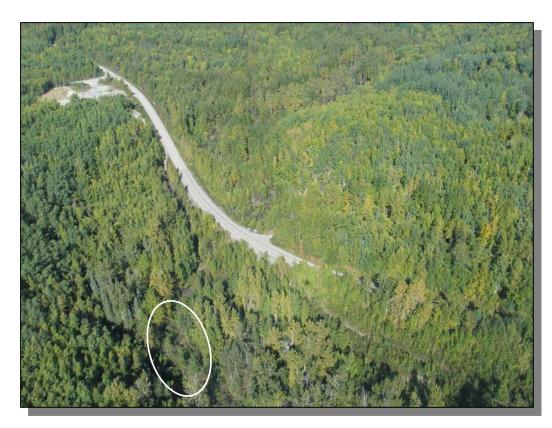
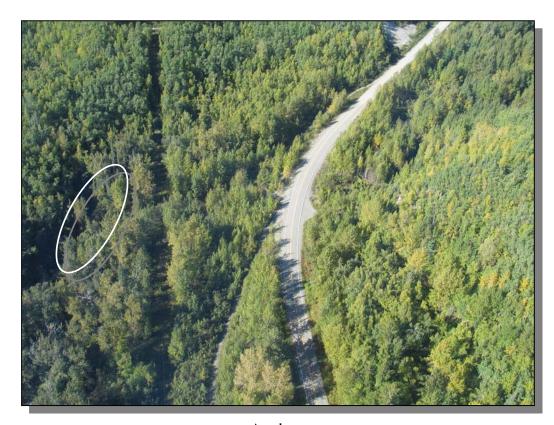
White oval indicates approximate location of Eska Creek crossing, facing upstream. Adjacent to Jonesville Mine Road.

As above.

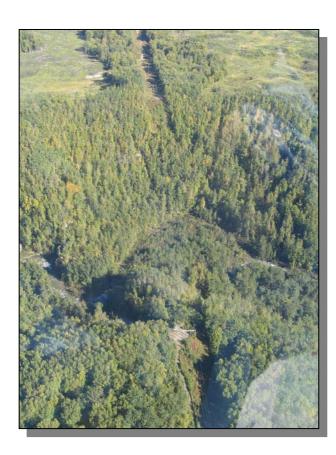
<u>Crossing Description</u>: Moose Creek is a high-gradient stream with meandering stream bed characteristics. Topographic relief of the pipeline crossing is approximately 100 vertical feet. Slope failures, both upstream and downstream, and on the right (west) bank along the alignment were observed. The immediate area of the proposed crossing is known as Tsadaka Canyon.

Proposed Moose Creek crossing is parallel with transmission lines, looking from right (west) bank.

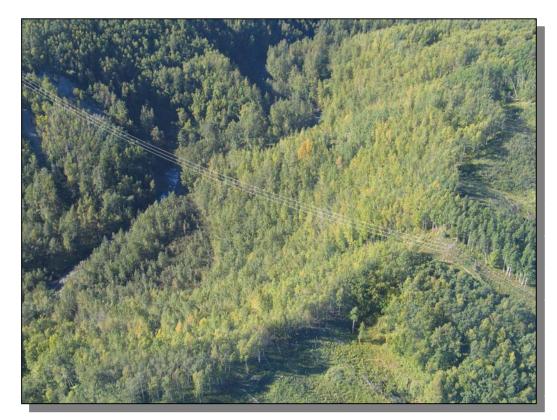
Proposed crossing is parallel with transmission lines, looking from left (east) bank.

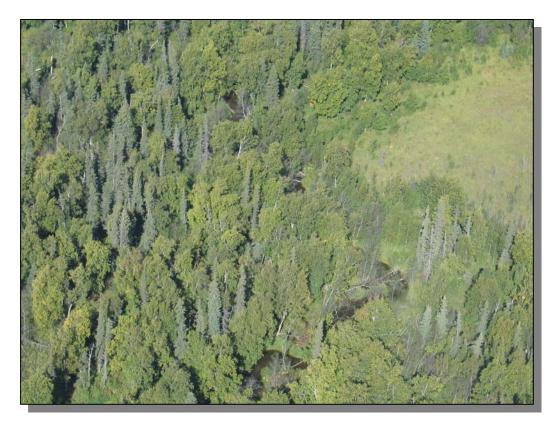
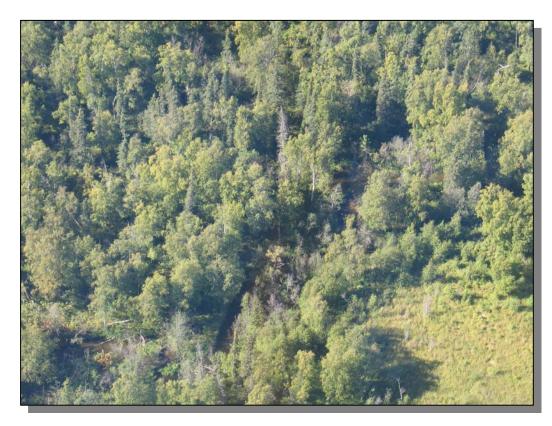
Overview of Carnegie Creek crossing. Stream flow is from top to bottom of photo.

As above.

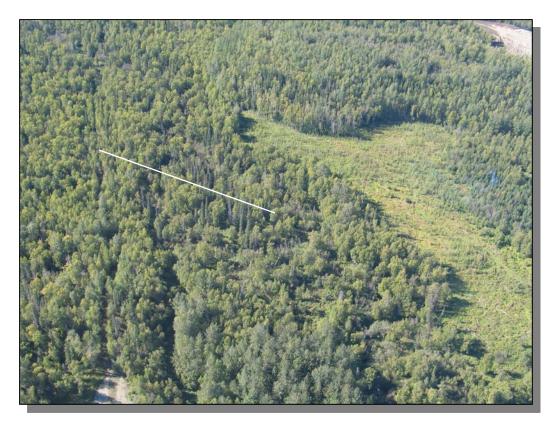
Overview of Wasilla Creek crossing; stream flow is from bottom to top.

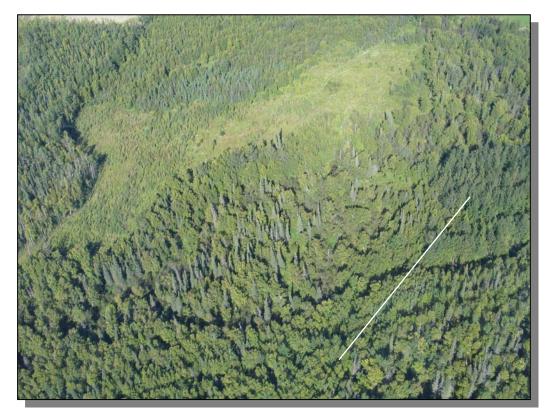
Overview of Wasilla Creek crossing; stream flow is from right to left.

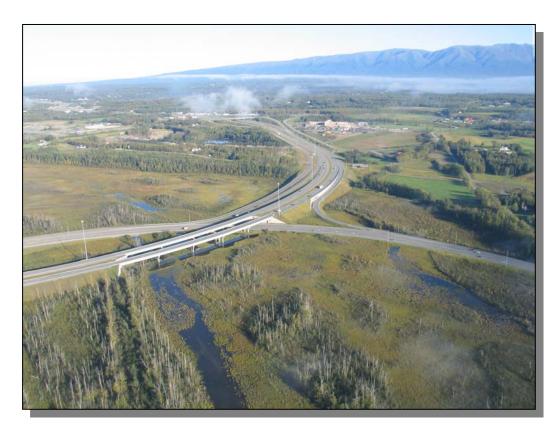
Overview of Spring Creek crossing, stream flow is from bottom (east) to top (west) of photo.

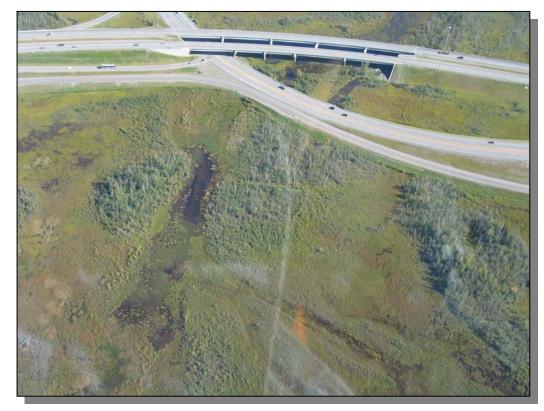
Overview of Spring Creek crossing, stream flow is from top (east) to bottom (west) of photo.
